WEBSTER SPRINGS, W. VA.  
NW/4 WEBSTER SPRINGS 15 QUADRANGLE  
N 3822.5—W 8022.5/7.5

## LANDSLIDES AND RELATED FEATURES OF THE WEBSTER SPRINGS, W.VA. QUADRANGLE

GREGORY C. OHLMACHER  
U.S. Geological Survey

OPEN FILE MAP 83-80 (D-13)

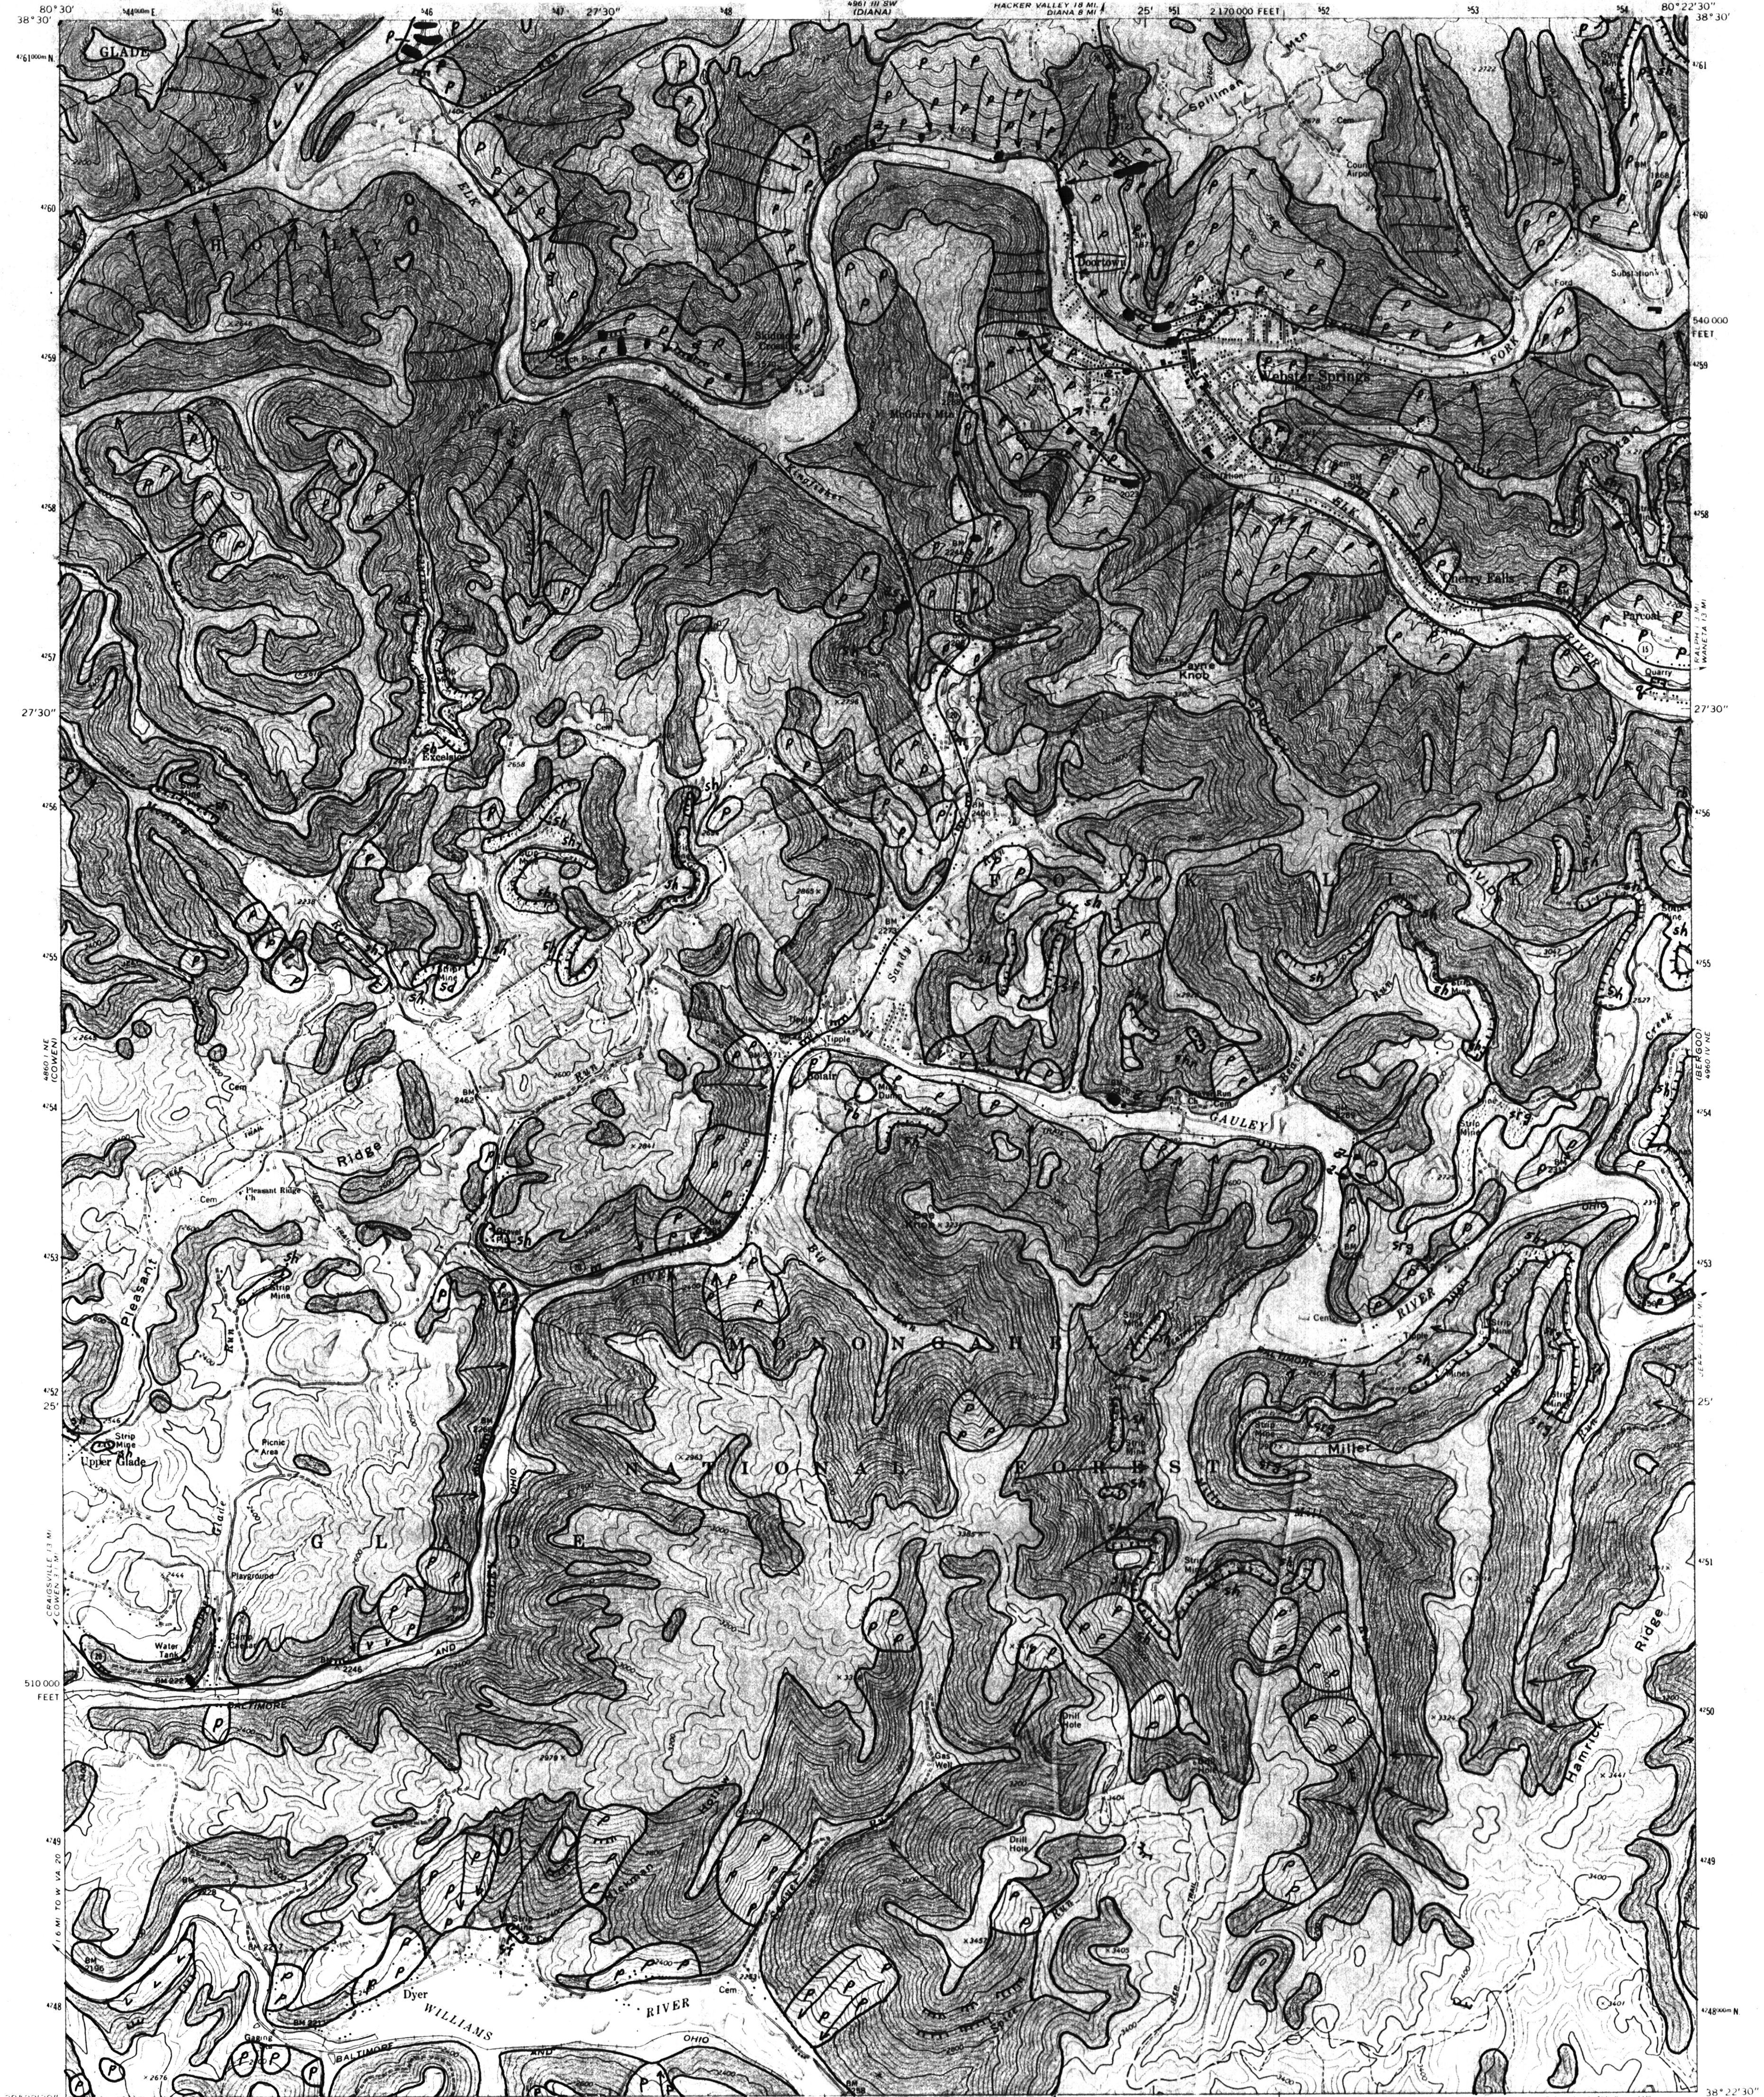
Landslides and related features interpreted  
from aerial photographs:  
1:60,000 SCALE BLACK AND WHITE 1960  
1:125,000 SCALE COLOR INFRARED 1973

Photointerpretation and field check 1981.  
This map has not been edited or reviewed  
for conformity with Geological Survey  
standards and nomenclature.

Information shown is intended as a  
general guide to ground conditions as of  
the date of field check. Additional  
landslides and rockfalls should be anticipated  
in all map units. The map unit depicts  
the dominant condition in the area delineated  
and variations in slope stability may occur  
at any point in the unit. This map is suit-  
able for general planning purposes and as a  
supplement to more detailed studies for site  
selection. The map cannot be used as a sub-  
stitute for detailed geologic and engineering  
investigations to establish design and  
construction criteria of specific sites.  
Some symbols may not appear on this map  
because the description is applicable to a  
series of maps.
